Investigation of Two Co-Seismic Rockfalls During the 2015 Lefkada and 2014 Cephalonia Earthquakes in Greece

ABSTRACT: The paper discusses two case studies related to earthquake-triggered rockfalls, one from Lefkada Island (Mw 6.5 earthquake, 2015) and one from Cephalonia Island (Mw 6.1 earthquake, 2014). The first one impacted a house in Ponti village resulting in one loss of human life while the second one occurred at the beach of Myrtos. Detailed characterization took place using an Unmanned Aerial Vehicle (UAV) and a high definition optical camera. Using the UAV-based imagery, three-dimensional models of the rockfall sites were created and were used as input for detailed rockfall analysis and to document the characteristics of the down-slope block movement. The rockfall impact points were identified by a field survey and UAV imagery. Based on the recorded earthquake ground motion characteristics, the initial velocity of the detached blocks was assessed and the rockfall trajectory was reconstructed in order to define the run-out distance for each case. It was found that the rockfall events were distinctively different in terms of kinematics, one having propagated by rolling of a

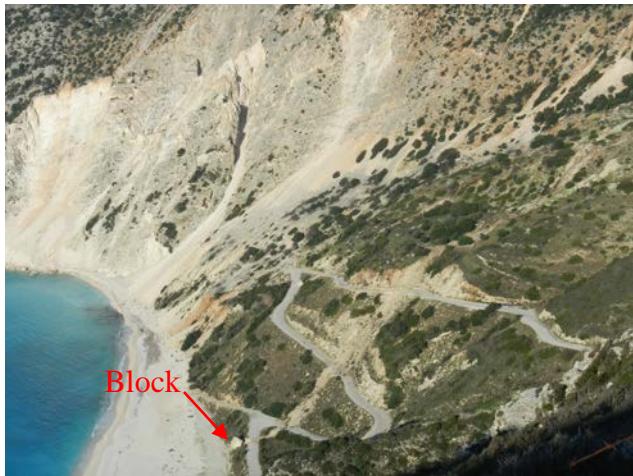
Figure 1. View of rockfall site at Myrtos beach.

Myrtos coastal area is located in the western part of Cephalonia Island in a transition zone, where Triassic–Middle Miocene limestones of Paxoi unit thrust with a reverse NW–SE striking fault (Agia Efthimia fault) over the Middle Miocene–Early Pliocene clay-clastic sequence of the same unit. This thrust fault, along with the presence of NE–SW and NW–SE striking active faults cut across Myrtos coastal area and form an unstable region. The slope is formed by white limestone, locally karstic. In places, the limestones are highly tectonised and form tectonic breccia due to the fault's presence and are overlain by slope scree formed by the weathering of the steep slopes, consisting of sands, gravels and irregular boulders (Figure 1).

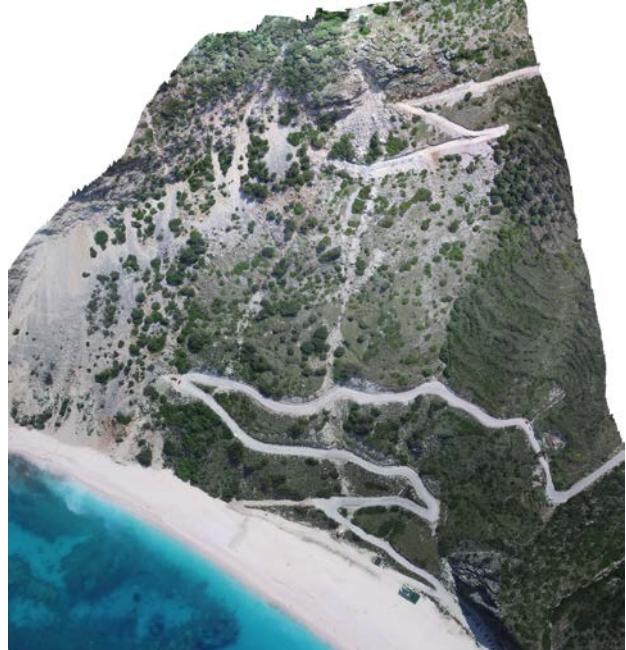
Figure 3. Orthophoto of Myrtos beach.

5cm pixel size orthophotos were produced by processing high-resolution image sequences through SfM photogrammetry software as shown in Fig. 3. The orthophotos were used to identify the rolling section of the rock throughout its entire course as shown in Fig. 4.

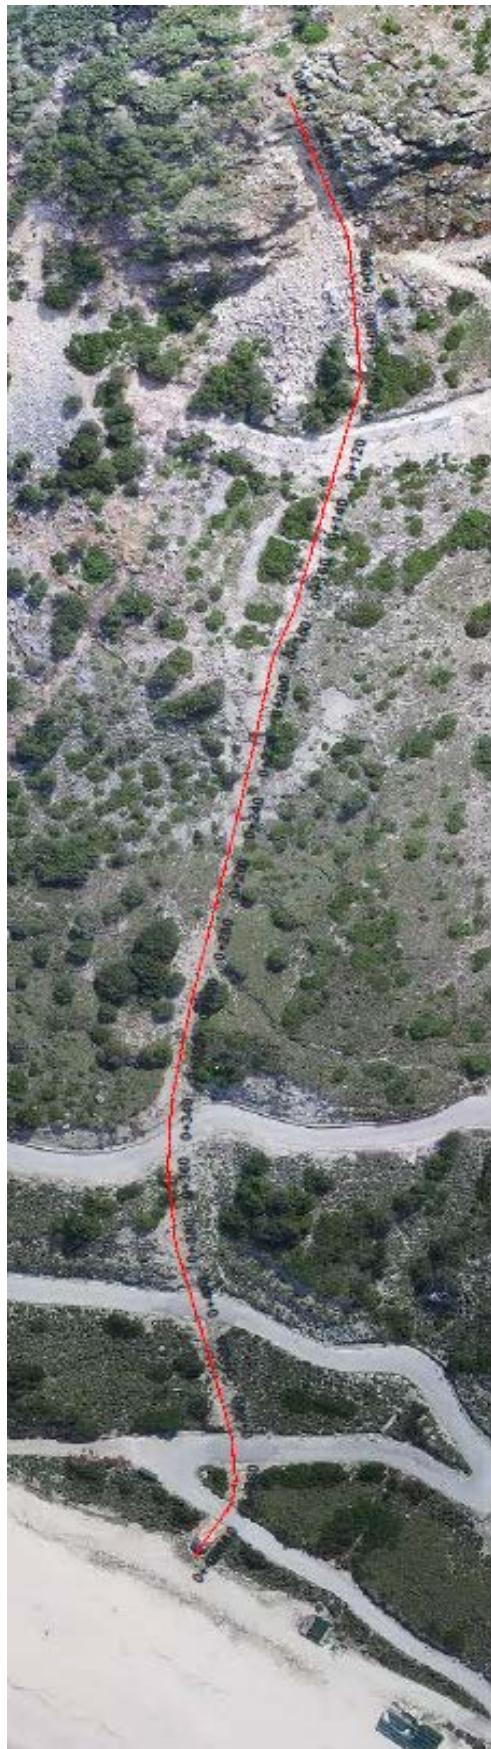
Figure 4. Rolling path of block in Myrtos.

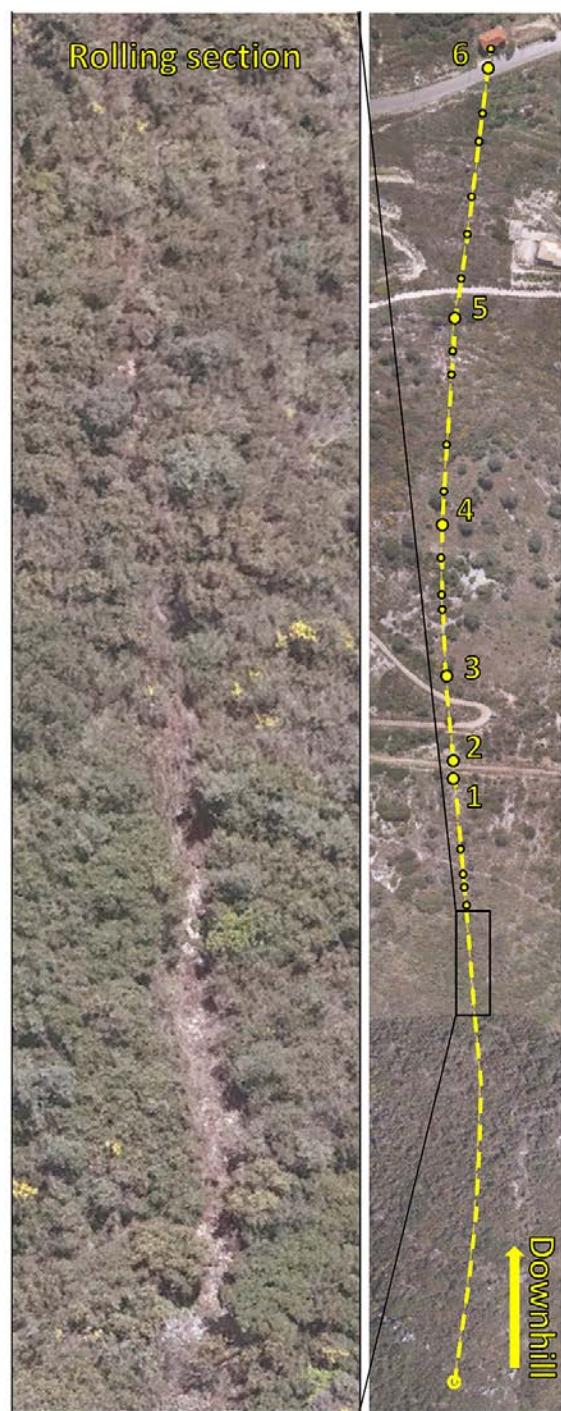
5cm pixel size orthophotos were produced by processing high-resolution image sequences through SfM photogrammetry software and were used to identify the rolling section and the bouncing points of the rock block throughout its entire course (shown in Fig. 5). The rolling section of the rockfall path was distinguished by a destructive linear feature through the vegetated terrain, which alters its colouring with a bare earth tint. In contrast, bouncing impact points stand out as ellipsoidal bare earth craters with no linear traces connecting them.

The final bouncing point before impact on the house is clearly visible on the asphalt road. Top view ortho-imagery proved to be invaluable for these qualitative assessments.

Figure 5. Top view orthophoto – Rolling section and bouncing positions recognition for the Ponti (Lefkada) rockfall.
