UAV-Based 3-D Characterization of Rock Masses and Rock Slides in Nepal

Greenwood, W., Zekkos, D., Lynch J., and Bateman, J.

Copyright 2016 ARMA, American Rock Mechanics Association

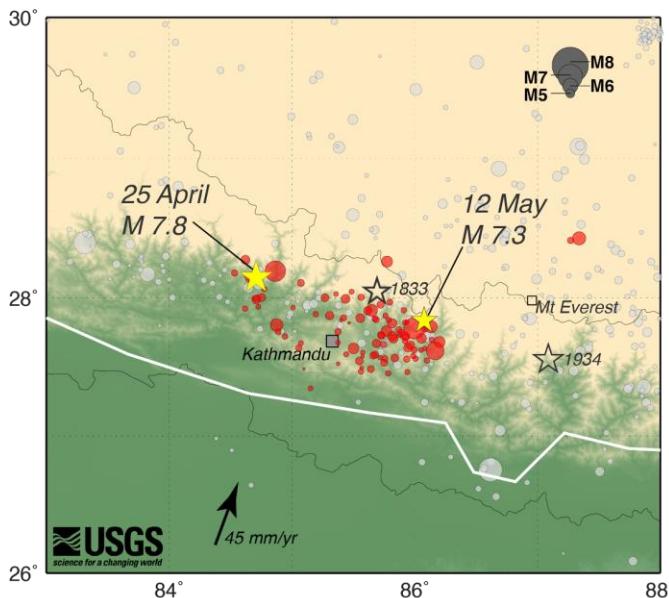
Fig. 1. Mainshock and distributed aftershocks of the 2015 Gorkha earthquake sequence (from Robertson and Koontz, 2015).

On April 25, 2015 the Gorkha earthquake (M_w = 7.8) caused widespread damage across Nepal. The series of aftershocks was headlined by the May 12, 2015 event (M_w = 7.3). Epicenters of the April 25, 2015 earthquake and other major events are shown in Figure 1. The main earthquake epicenter was located about 80 km northwest of Kathmandu and resulted in a 140 km rupture segment along the Main Himalayan Thrust (Galetzka et al., 2015). Previous major seismic events in this region are discussed by Hayes et al., 2015. This event resulted in

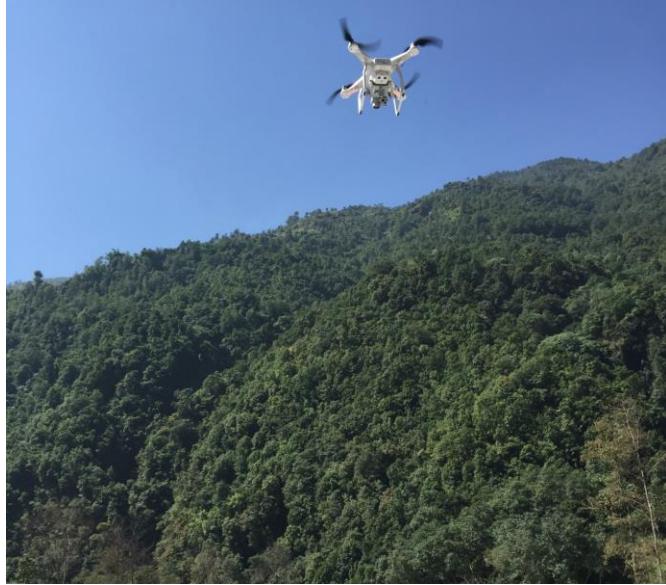
Fig. 2. DJI Phantom 3 Professional platform used in field reconnaissance.

The camera-equipped UAV used as part of this study was the Phantom 3 Professional (P3P) from DJI. The P3P operates with an integrated optical camera coupled to the UAV with a triaxial gimbal. The camera is capable of collecting still photos and high-definition video. Some details of the P3P UAV platform and the integrated camera are outlined in Table 1. The P3P and related platforms have been used in other recent studies including those related closely to civil engineering applications (Gillins et al., 2016). The P3P UAV platform is shown in flight in Figure 2.

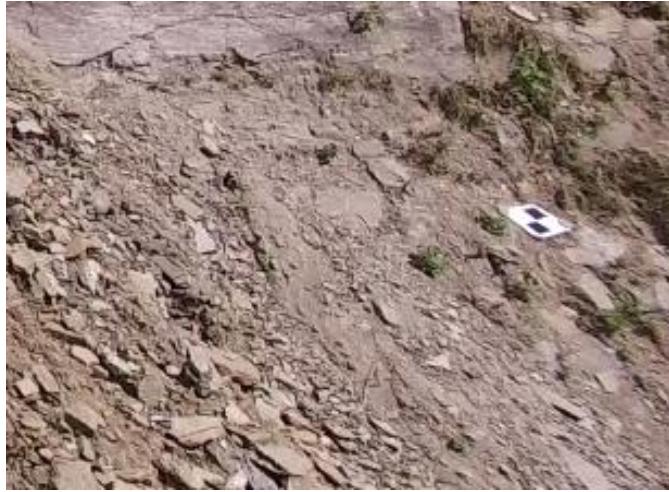
Fig. 3. Example of deployed GCP target.

The UAV was manually flown from the ground to reposition the camera for data collection. Ground control point (GCP) targets, generally about 3-8 in total, were placed at the sites where accessible. The distances between these GCP targets were measured manually, using triangulation, using a measuring tape as well as a handheld GPS unit. The GCP targets are easily detected in imagery and, usually, in 3-D point clouds. An example of a deployed GCP target is shown in Figure 3. A tripod-mounted laser was also used to measure the distance between points-of-interest on the landslides.

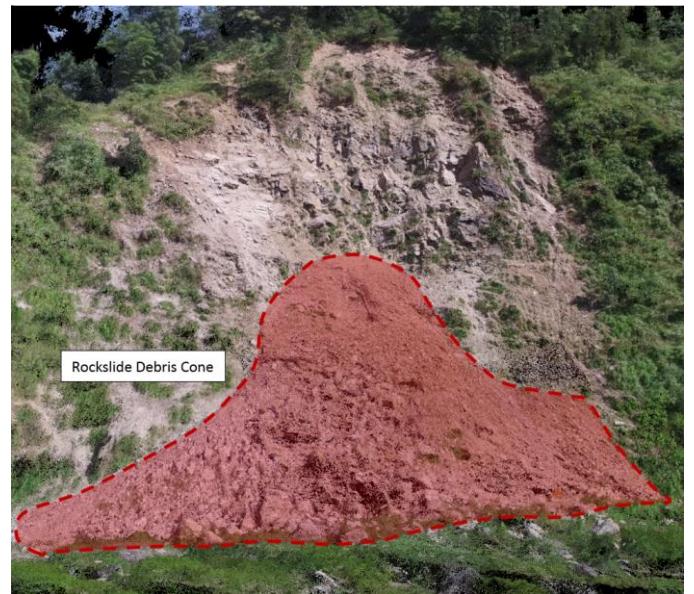
Fig. 4. Overview of Landslide 1, near Melamchi (3-D point cloud).

The first landslide site (Landslide 1) was located about 30 km northeast of Kathmandu, near Melamchi. At this site a roughly 75 m high rock-slope failed. The slope is, on average, angled at about 70° from the horizontal. However, the top 5 m of the slope is angled at about 50° . The rockslide is indicative of a failure of a broken-up rock mass that is mechanically characterized as Hoek and Brown strength material (Hoek and Brown, 1980). An overview of the rockslide is shown, as a point cloud, in Figure 4. The 3-D point cloud was generated from 257 images of the site. The debris cone outlined in Figure 4 is sloping at about 35° . The landslide scarp exposes the rock mass structure over an area that is approximately 40 m high and 45 m wide. The distribution of GCP at this site is shown in Figure 5. The targets are placed in accessible locations on the landslide debris. An annotated cross-section through the point cloud is shown in Figure 6. The 3-D point cloud has a mean resolution of 6 cm/pixel. Images collected

perpendicular to the landslide scarp were collected at two distances, roughly 30 m and 70 m. The UAV was flown as close as 15 m above the debris cone.

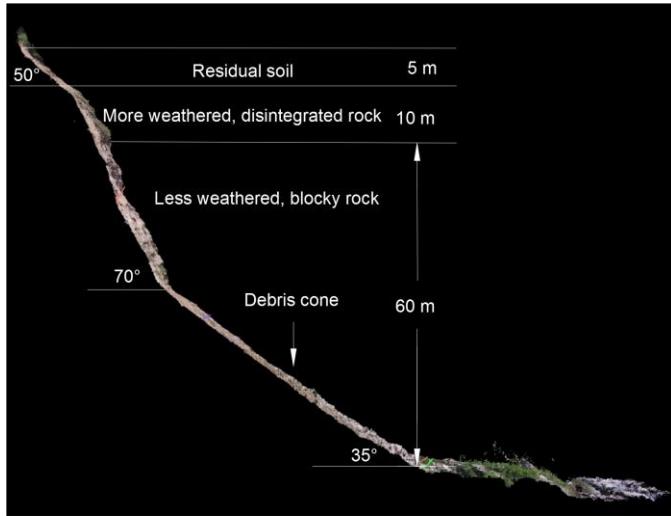
Fig. 6. Cross-section of Landslide 1 point cloud.

Generalized stratigraphy can be interpreted from the visual observations of the collected imagery and the 3-D point cloud. These interpretations were investigated in the 3-D point cloud in order to characterize the discontinuities in the rock mass and overall rock structure. As shown in Figure 7, the surface layer at the top of the slope is about 5 m thick and contains predominantly soil and extremely weathered rock. The remainder of the exposed rock can be separated into two

additional sections. A shallower layer, located between about 5 m and 15 m from the top of slope. This layer is more weathered rock with dominant horizontal foliation, and classifies as disintegrated rock per Marinos et al., 2005. The Geological Strength Index (GSI) is a critical parameter for the geomechanical characterization of the rock mass structure and is a function of the rock structure and the weathering condition of discontinuities. According to visual observations, the GSI for this layer is estimated to be on the order of 25-45. Horizontal fractures are spaced at 0.4 – 0.8 m throughout the layer. The next layer is located between 15 m from the top of the slope to the base. This layer is less broken-up rock with perpendicular vertical/horizontal fracturing aligned with the slope face, and classifies as blocky per Marinos et al., 2005. The GSI for this layer is estimated to be on the order of 45-65. The spacing of horizontal fractures is 2 – 3 m and the spacing of vertical fractures is 0.3 – 0.9 m. A delineation of the landslide layers in the point cloud is shown in Figure 8. It should be noted that, beyond about 40 m from the top of slope, the rock structure is hidden by the slide debris at the bottom of the slope. A small portion of rock was exposed near the top of the debris cone and indicated dominant horizontal foliation. However, the persistence of this structure cannot be confirmed without excavation or extensive investigation of the slope.

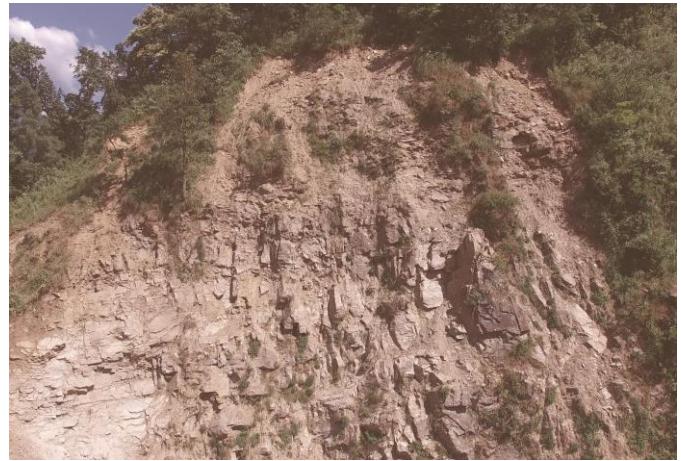
Fig. 7. 2D View of the back-scarp of Landslide 1 where the top two layers of the weathering profile can be seen.

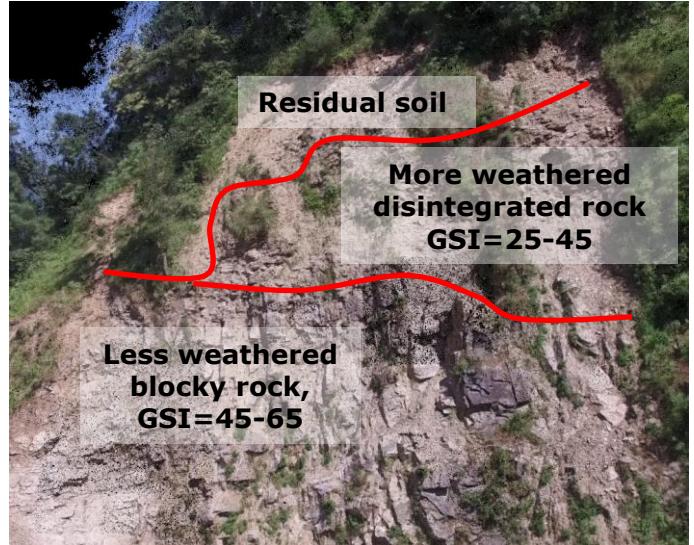
Fig. 8. 3D point cloud of the back-scarp of Landslide 1 with annotated layers and Geologic Strength Index (GSI) parameters per Marinos et al., 2005.

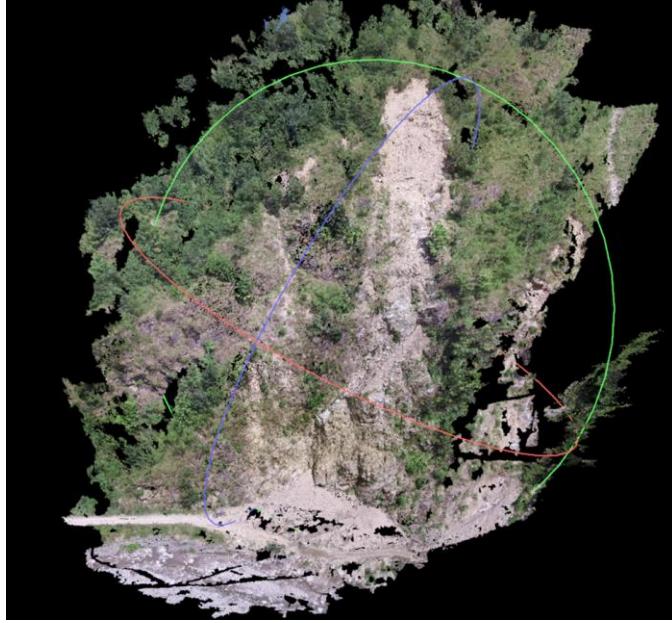
Fig. 9. Overview of Landslide 2, east of Kathmandu.

The second landslide site (Landslide 2) investigated in this study was located about 28 km east of Kathmandu. The failure occurred on a roughly 150 m high slope angled at about 65° from horizontal. An overview of the rockslide is shown, as a point cloud, in Figure 9. Unlike Landslide 1, Landslide 2 appears to have exhibited a combination of modes of failure. The rockslide is characterized by a shallow failure of a broken-up rock mass up-slope of a structurally-controlled, wedge type failure. The distribution of GCP and laser points is shown in Figure 10. GCP were placed on the landslide debris field and along the road adjacent to the base of the landslide. Laser points are located both in the debris field and on the landslide scarp. The UAV was flown as close as 40 m and as far as 80 m from the landslide scarp near the top of the slope. At the structurally-controlled failure, the UAV's camera was positioned 10-15 m away. This allowed for improved detail in the images of the rock structure at this critical location.

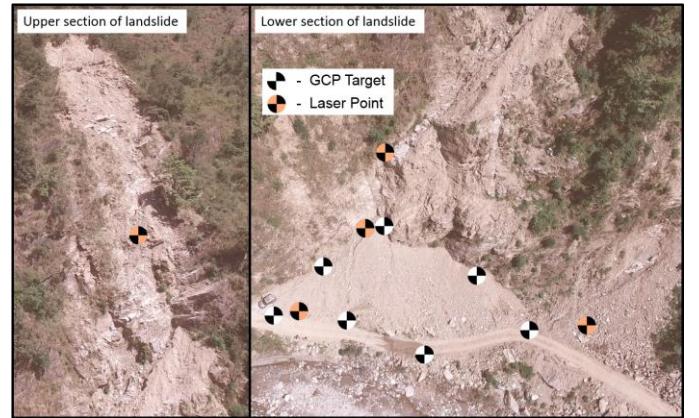
Fig. 10. Distribution of GCP and laser points on Landslide 2.

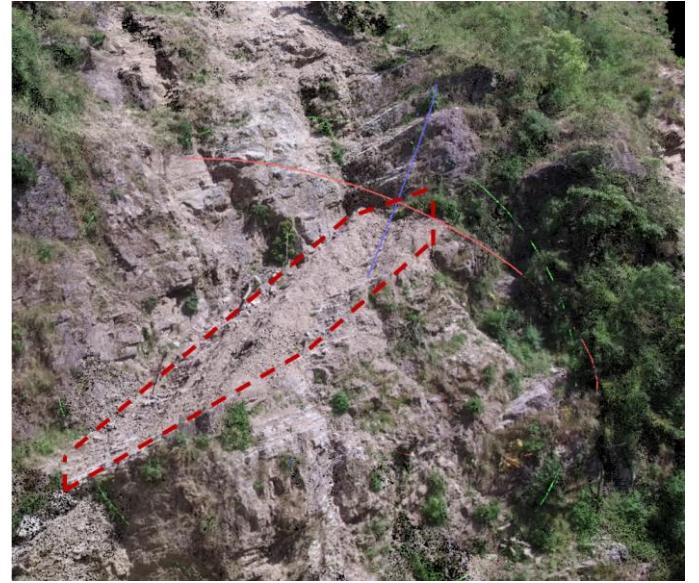
Fig. 11. Possible structurally-controlled failure in Landslide 2.

The failure is shown in the 3-D point cloud in Figure 11. A large block of the material was observed on the landslide debris along the road, probably originating from the failed wedge.

The rock, at this point, has few vertical fractures and is governed by foliation. Similar to Landslide 1, there is evidence in the 2-D imagery of foliation in the rock. However, in this case, the foliation is also visible in some sections of the 3-D model. This is due to the improved model resolution of Landslide 2 compared to Landslide 1. The mean resolution of this model is 1.2 cm/pixel, compared to 6 cm/pixel previously. In the sections of the model with the greatest resolution, small features and discontinuities are visible, such as the foliation. The improved resolution in this model is primarily due to the flight path taken by the UAV. The camera was positioned significantly closer to the
